Service Department

Troubleshooting - PD5100 Series ATS

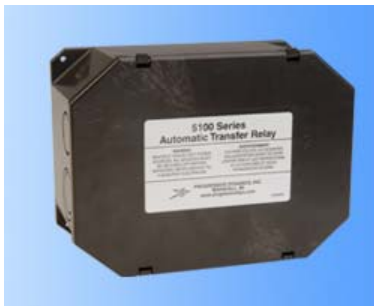
1. Disconnect all AC power from the RV and make sure the generator is "OFF"
2. Remove the cover from the ATS by sliding a screwdriver blade under the edge of the cover and pry off.

Use the blade of a screwdriver to pry off the cover of the ATS

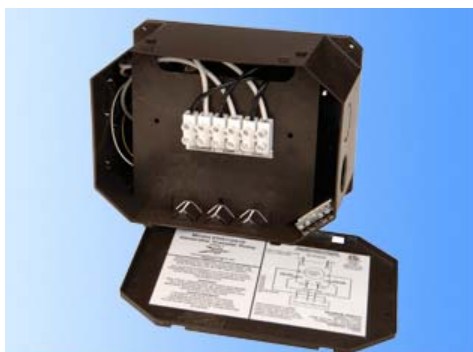
Replacing the ATS Circuit Board

Disconnect all AC power from the RV and turn the Generator "OFF".

1. Pull the circuit board out of the plastic housing and then using a screwdriver blade, pry the Yellow, White,

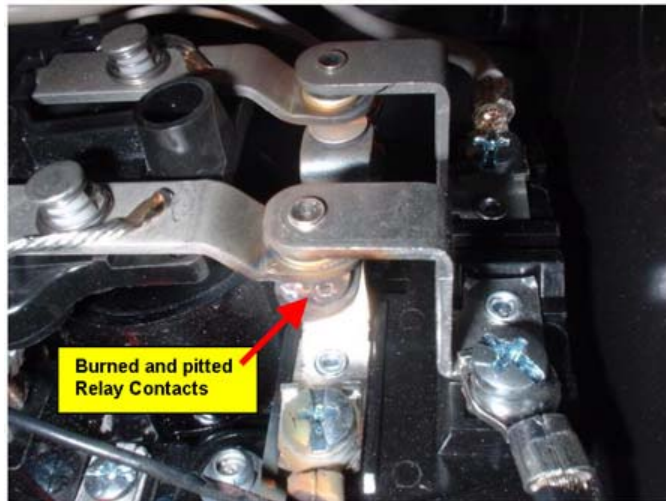
Relay Contacts Burned and Pitted

If the Relay Contacts are burned and pitted (see photo below), the Generator has a problem and it's voltage is dropping below 90 VAC under load. If this problem occurs, you must repair or replace the Generator and the complete ATS.
