Bill & Kelly's American Odyssey (<http://bkamericanodyssey.com/>)

Bedroom Slide Floor Repair

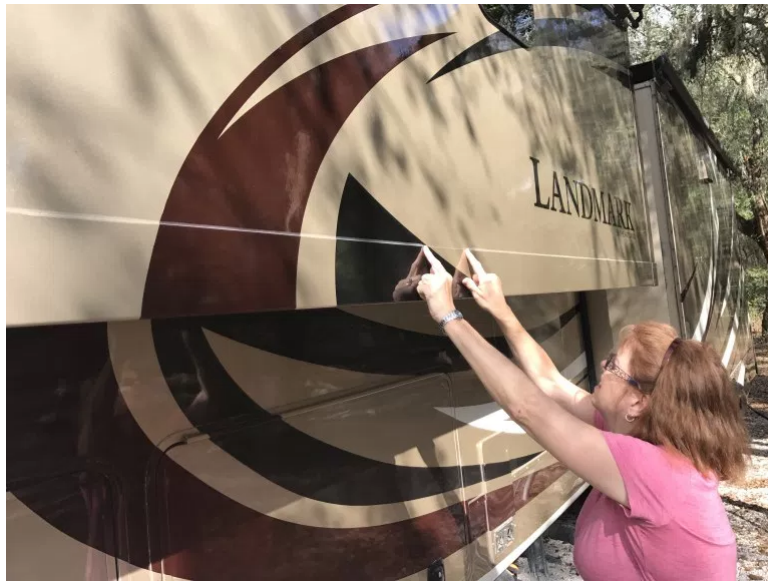
Not sure when it was I mentioned it before, but water had got into our bedroom slide and damaged the floor. There was a gap in silicone between the wall and the trim piece, about 5 inches, and it was enough to cause some rot to develop in the floor.

The area between my fingers is missing silicone caulk

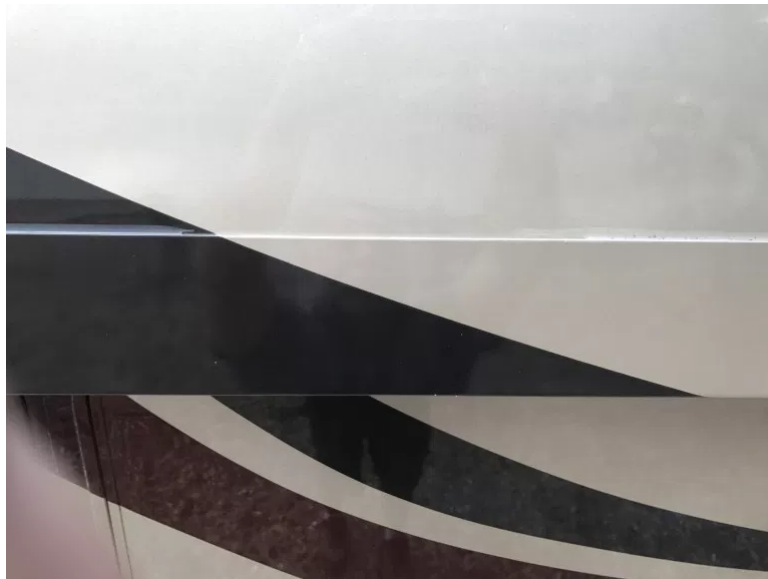
If you zoom in you can see where the caulk is missing

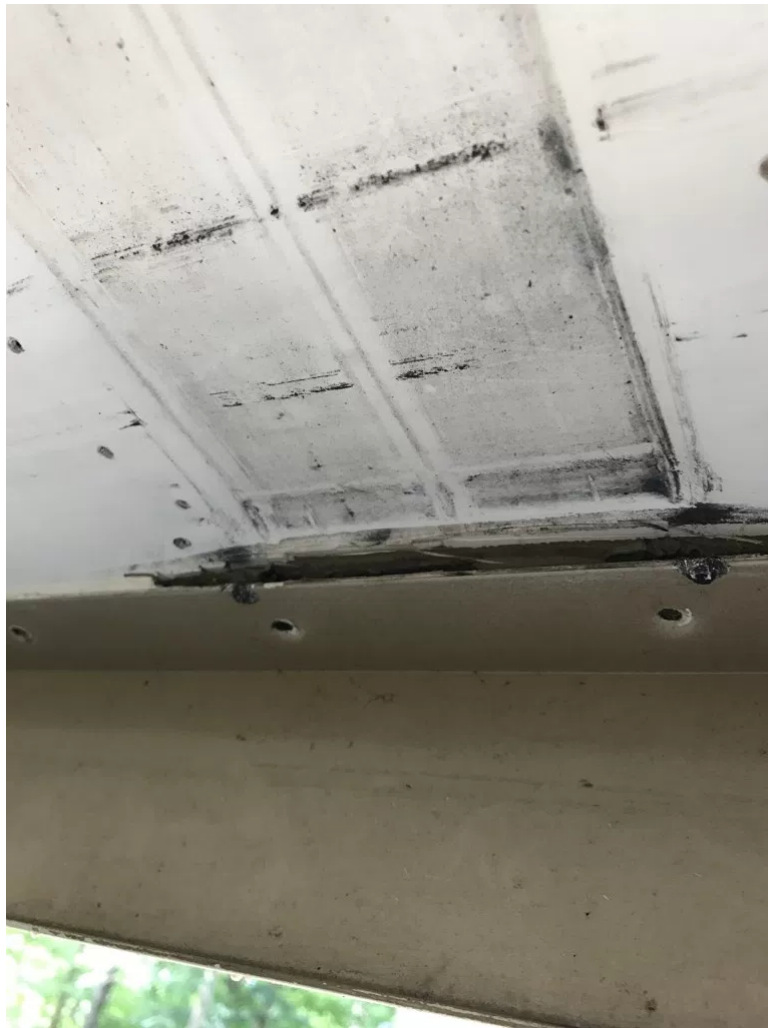
This is the outside of the bottom of our bedroom slide looking up, our bedroom slide is much longer than most, due to it extending into the hallway (our bedroom stairs are opposite the door) – you can also see that the screws have fallen out

As you can see when comparing - the top pic shows the floor pushing up where the floor roller sits when the slide is in. This is because the wood is rotted.

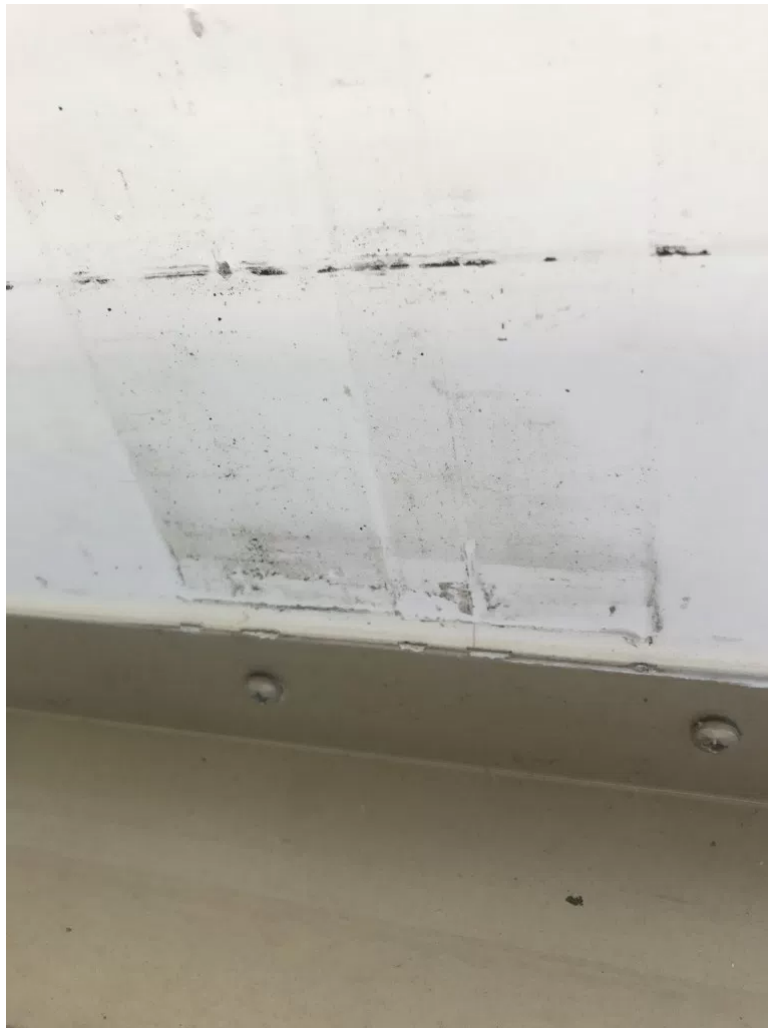
This is what it should look like

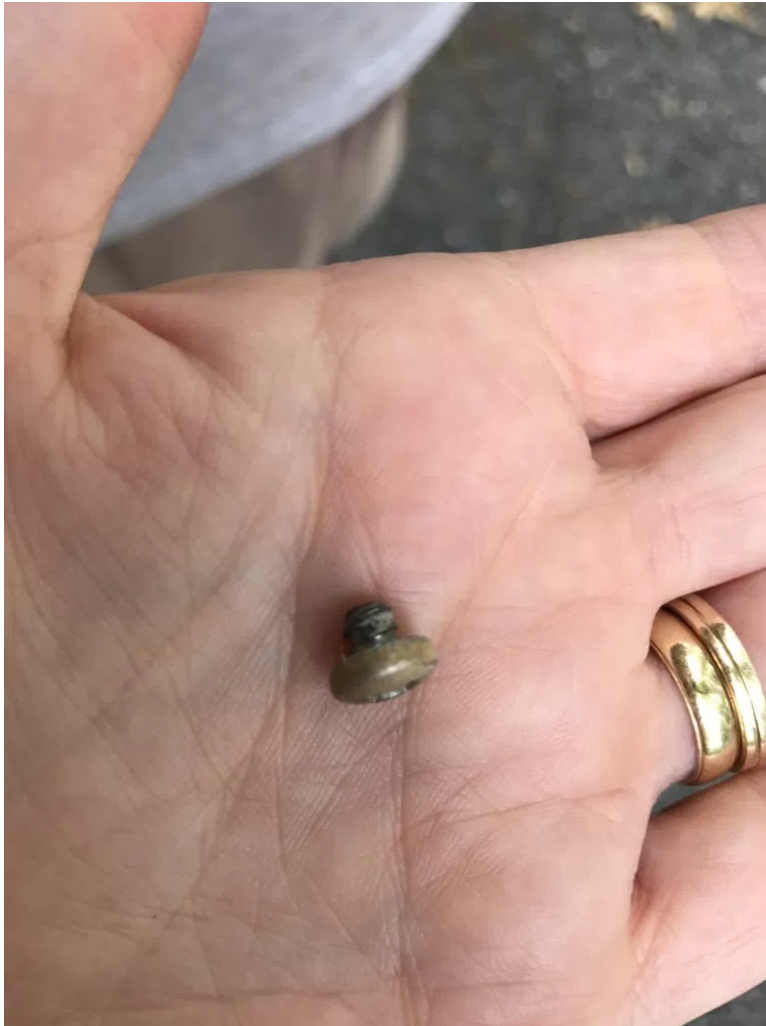
This screw didn't fall out, but did break off when Bill removed it due to rust

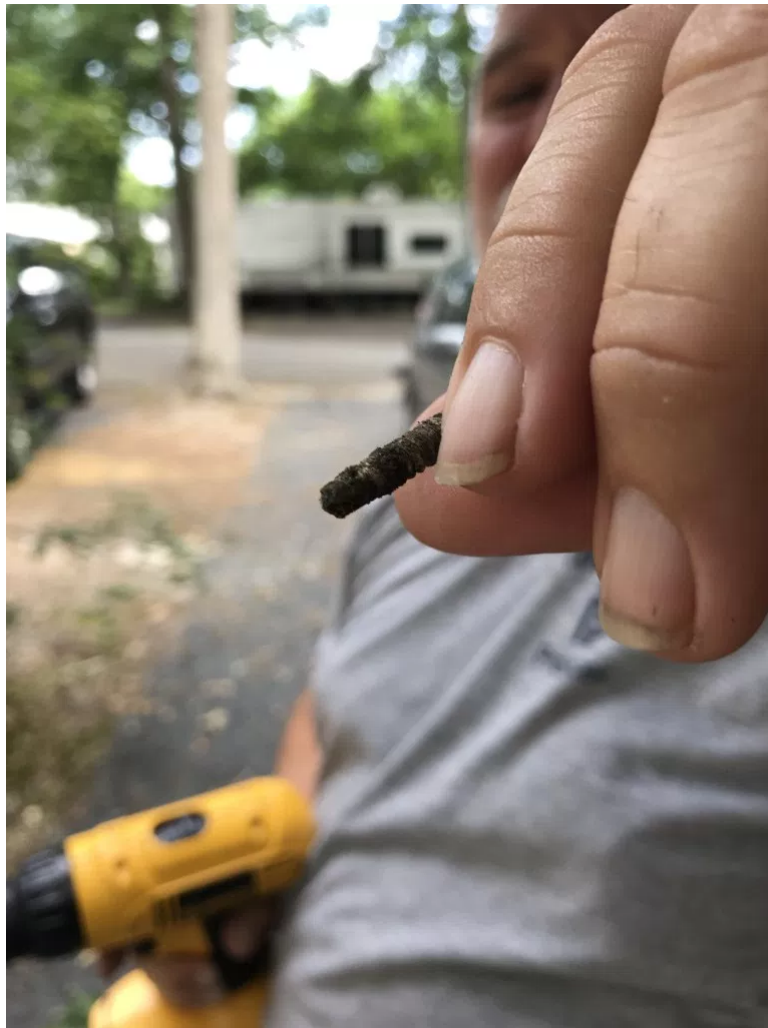
This one is rusted but not bad enough to break - yet - I'm sure it would have eventually

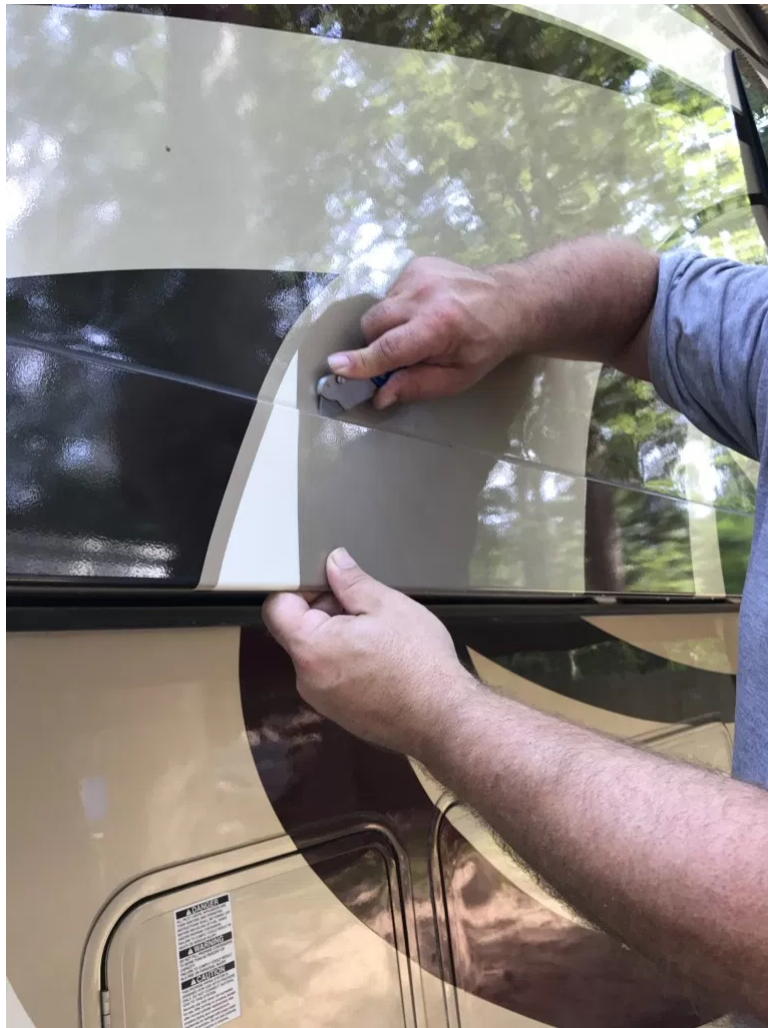
Cutting the silicone caulk. This is the area that was missed causing the leak and damage!

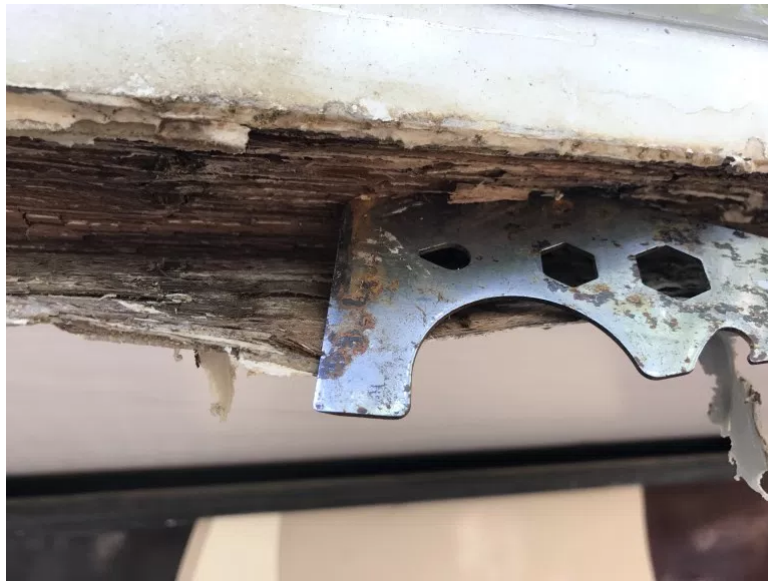
First peek at damage - UGH - worse than expected!

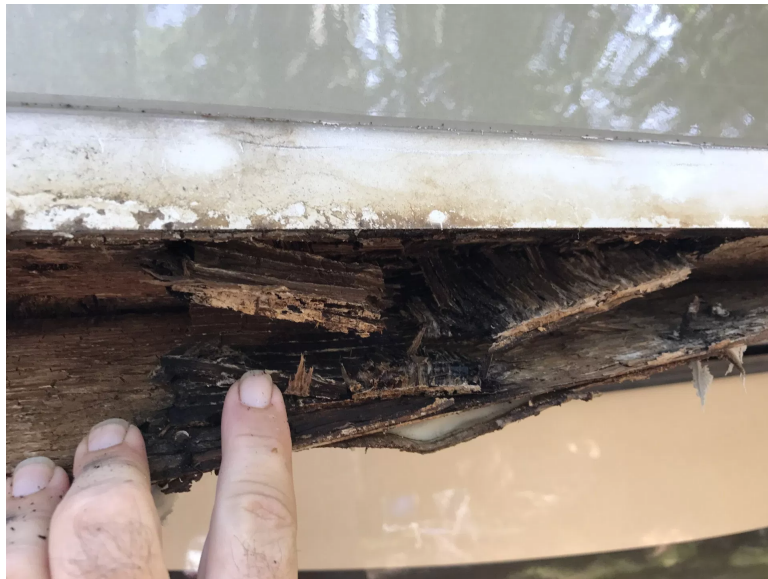
This area of floor is literally crumbling apart!

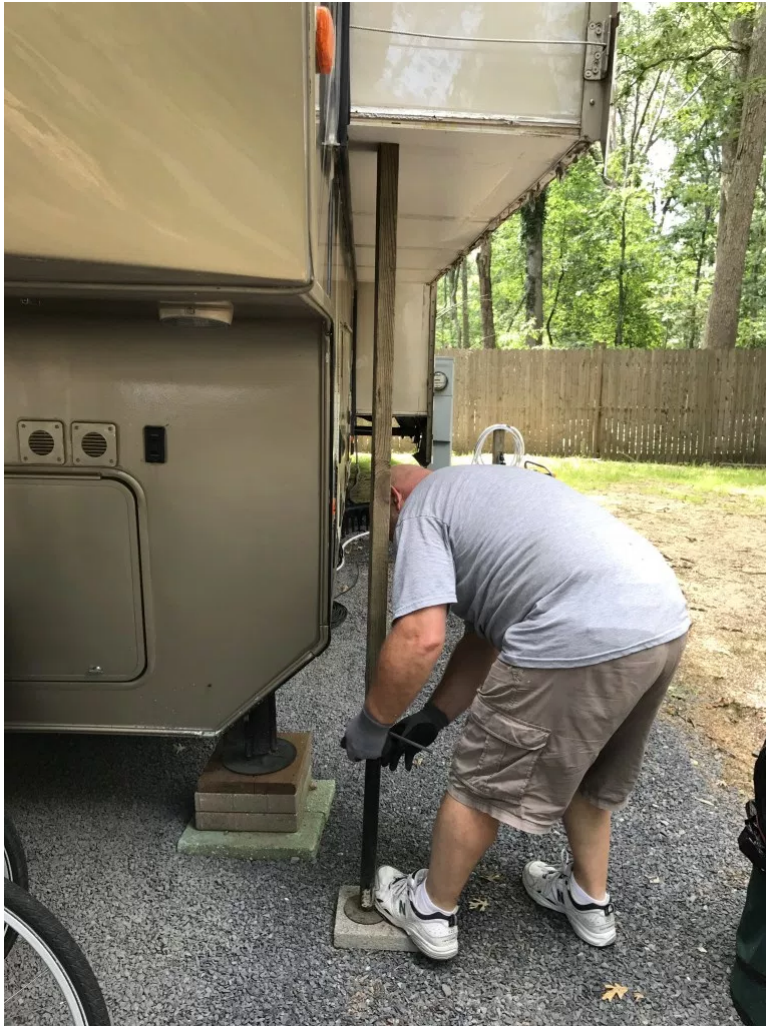
Jacking up 2x4's to hold the weight of the slide

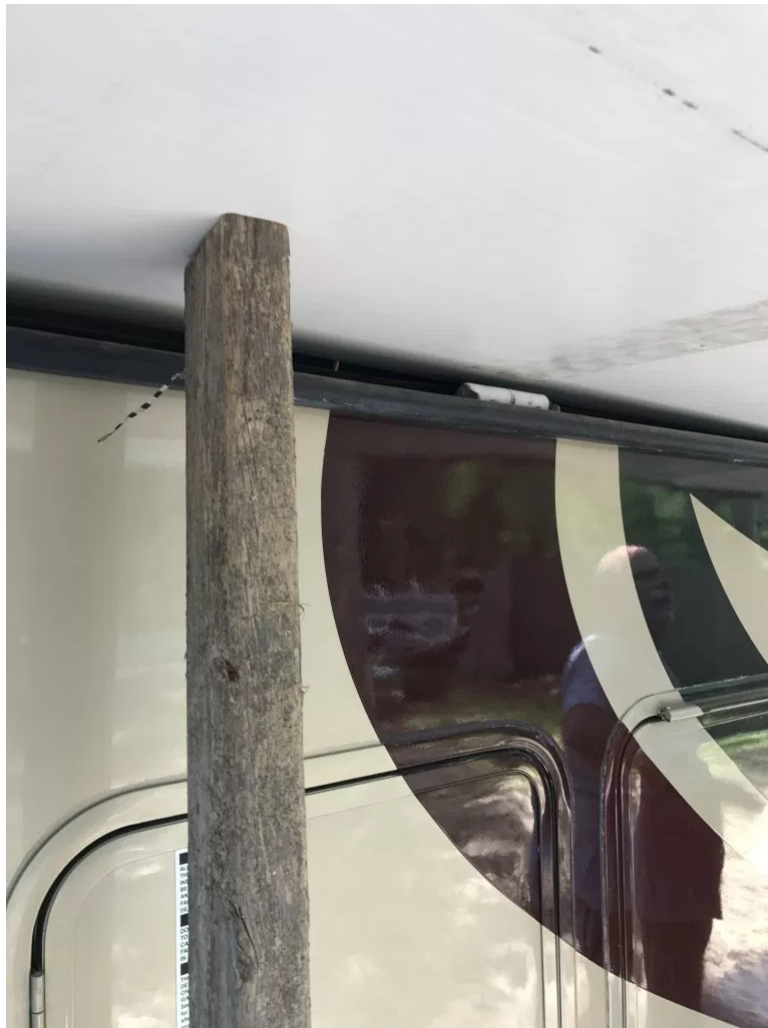
Bill was able to get the end slides fully off the rollers because the weight could be on the wall area, but the middle would not lift high enough. If we had a "usual" bedroom slide it would have been possible, but this slide is 13' long. There isn't anywhere to support the middle.

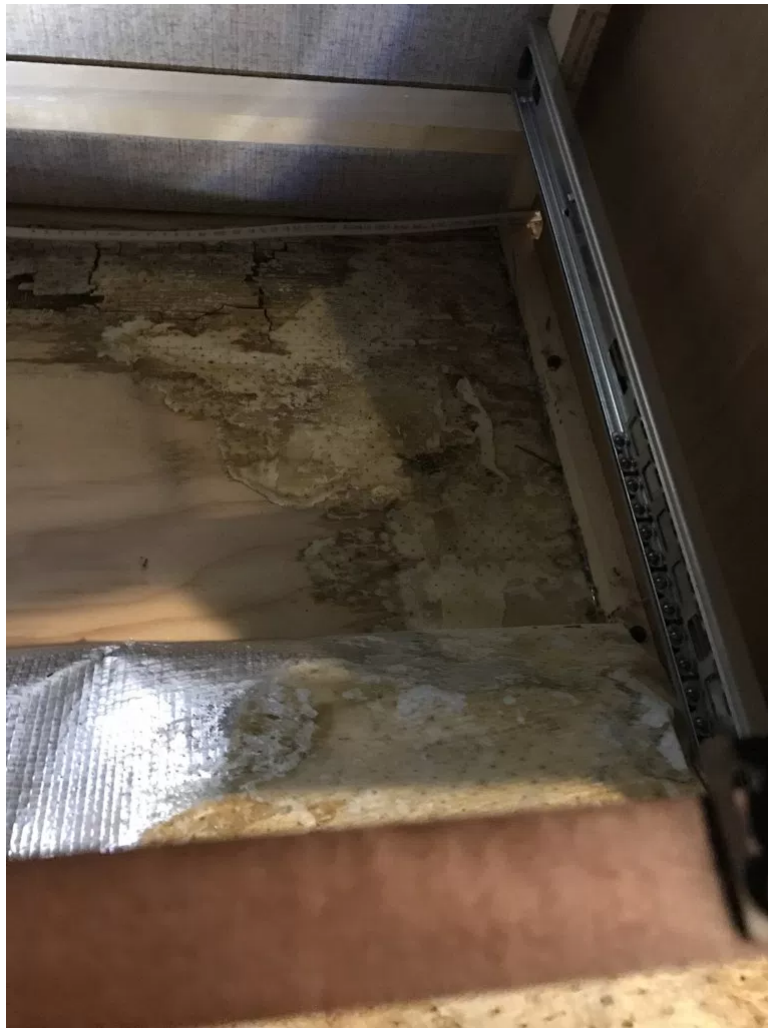
Ok - now that's BAD - yuck!

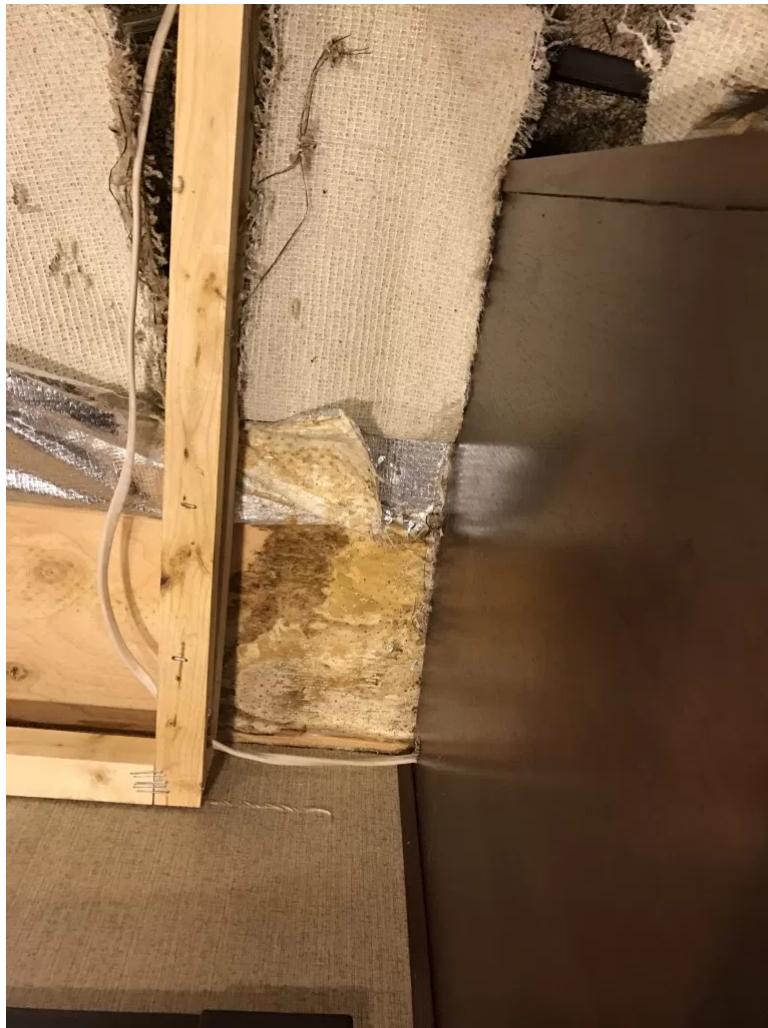
More damage

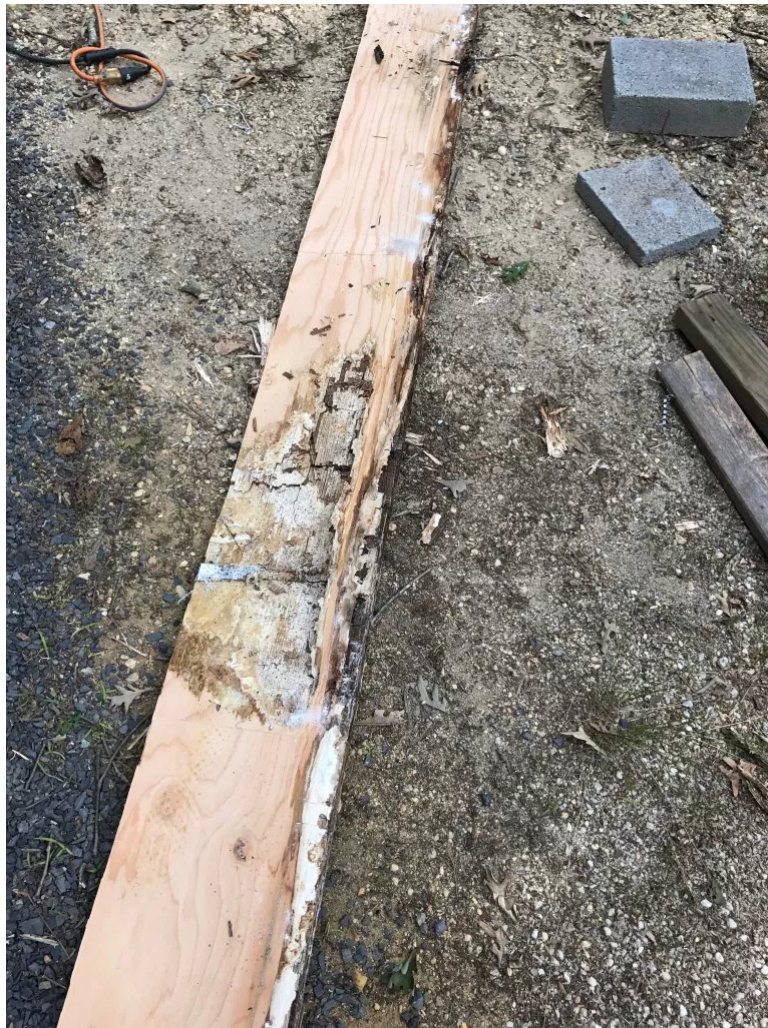
Close up of damage

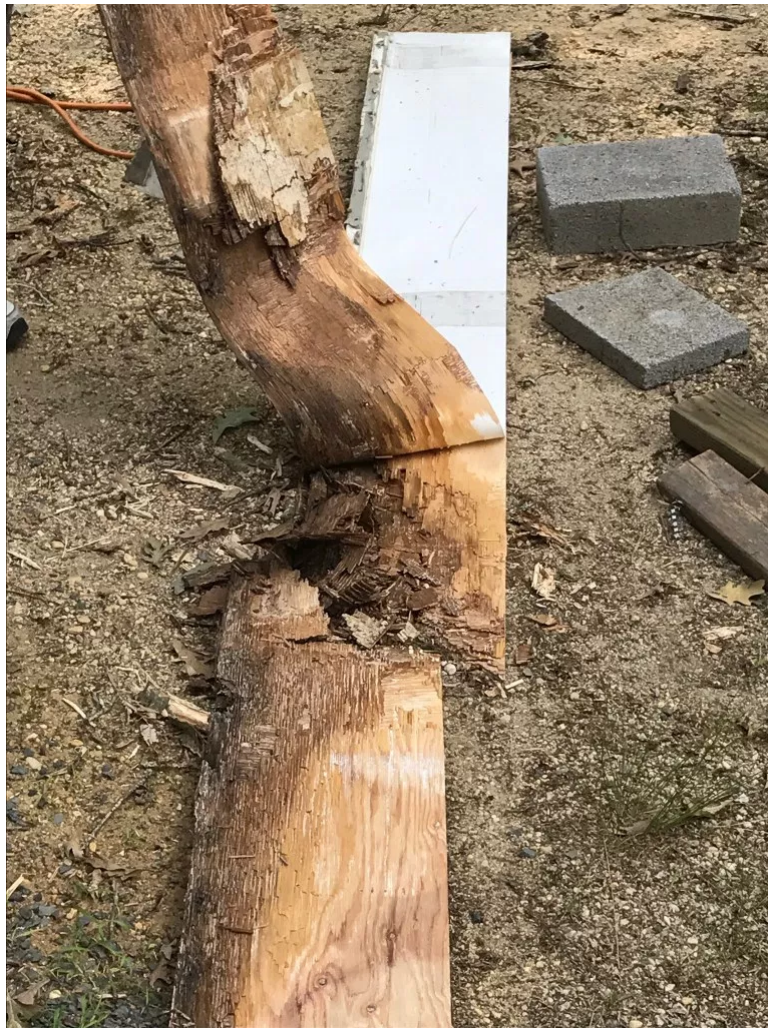
Outside plastic covering pulled away showing totally rotted wood
